*Saatova Nodira Ziyayevna,
doctor of philosophy (PhD), docent
Tashkent State Transport University,
of the department "artificial structures on highways", Uzbekistan*

EFFECT OF SALT CORROSION ON DECREASING CAPACITY OF ROAD BRIDGE SPAN ELEMENTS

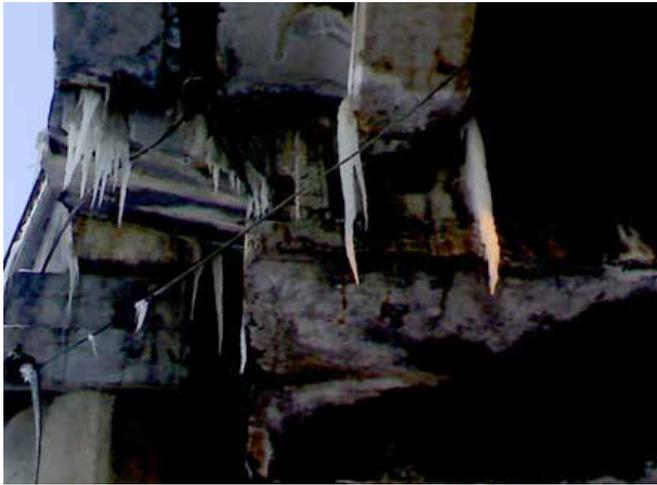
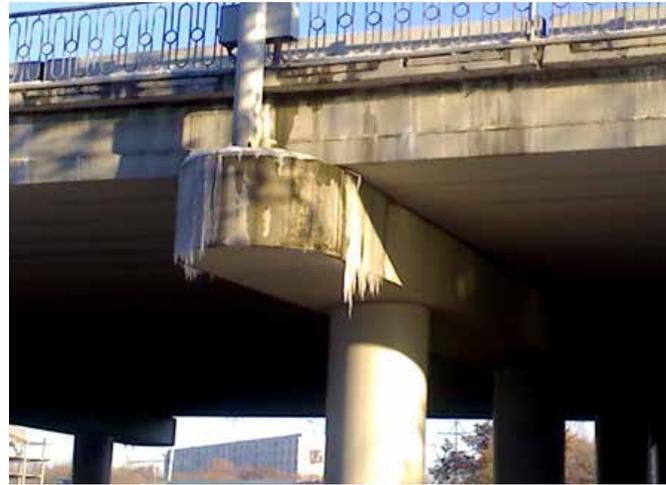
Photo 1. Salt water quickly enters the concrete body, in case of existing waterproofing failures and expansion joints:

a) overpass on Babur Street (Tashkent); b) overpass on Bunyodkor street (Tashkent)

the bridge after the use of de-icing reagents, and with the existing faults of waterproofing and expansion joints salt water quickly enters the body of concrete (photo 1). A sharp increase in ambient temperature contributes to intensive drying of concrete, and the amount of salt deposited in the body of concrete in

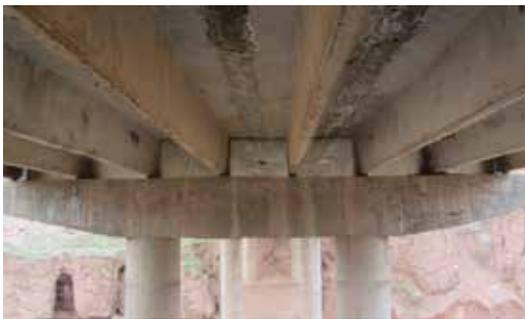
Photo 2. Traces of leaching and corrosion on the surface of beams and cast-in-place concrete

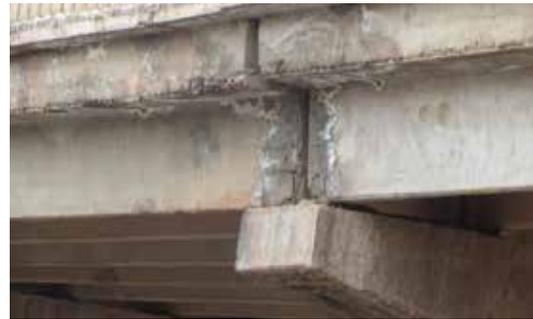
Photo 3. Corrosion of concrete at the ends of the extreme beams

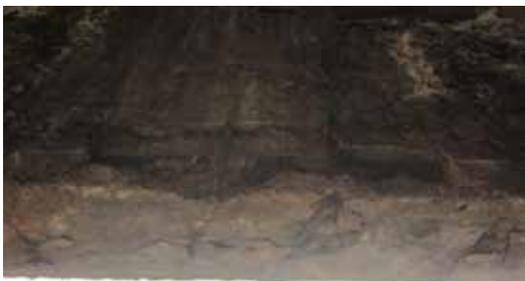
Photo 4. Destruction of the lower part of the beam rib

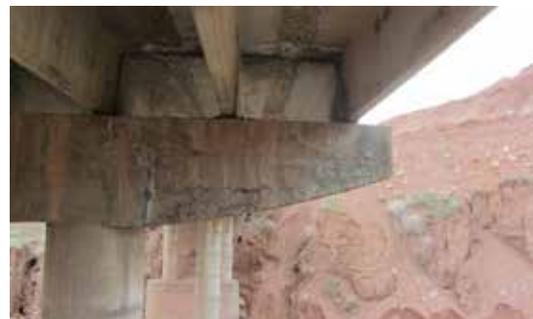
Photo 5. Corrosion of the concrete crossbar and a network of cracks on it

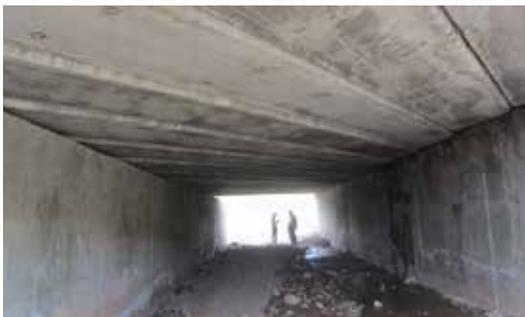
Photo 6. Traces of leaching and corrosion of concrete on the surface of the beams

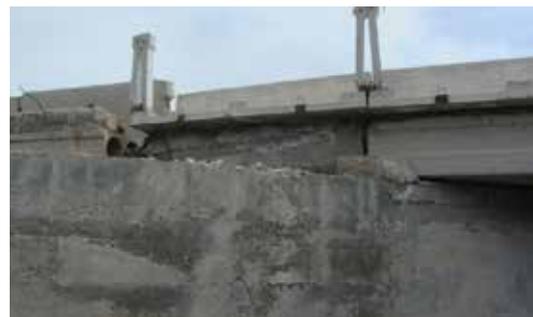
Photo 7. Reinforced concrete slabs installed without bearings

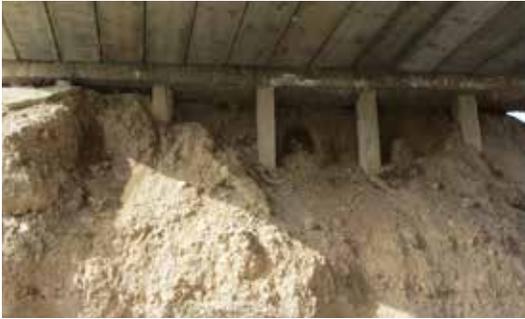
Photo 8. Traces of leaching and corrosion on the surface of the beams and abutments of the bridge

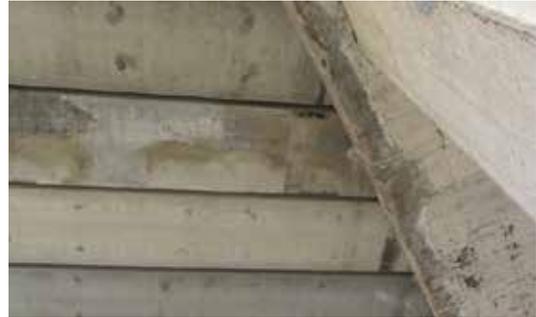
Photo 10. Traces of leaching and corrosion of concrete on the surface of slabs of superstructures

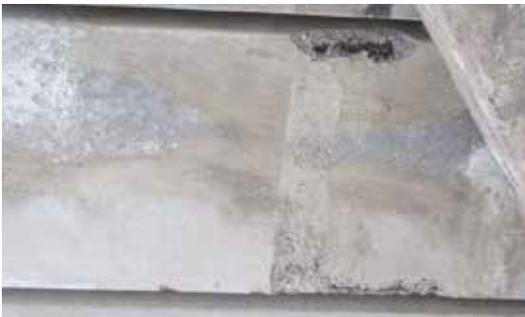
Photo 11. Peeling off the protective layer of concrete and exposing the reinforcement in plate No. 12

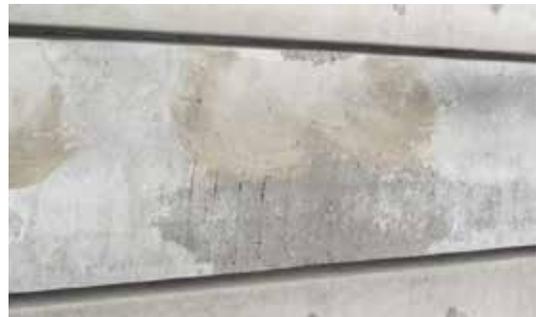
Photo 12. The longitudinal seams between the tiles are not filled with concrete
