DESIGN OF LI-ION BATTERIES FOR PORTABLE ELECTRIC TRANSPORT

Abstract. During the work, the designs of traction batteries for portable electric transport were considered and analyzed. Serious flaws have been revealed that battery manufacturers carefully hide. The inability of balancing BMS boards to prevent long-term effects of overcurrent on elements has been theoretically proven. The next task of our research was the design and manufacture of the first Li-ion battery, which in its design was similar to factory analogues. During the operation of the battery, the inability of the BMS board to regulate the charge current was practically observed. After analyzing the shortcomings of the first Li-ion battery prototype, they concluded that it was hopeless. The production of the second Li-ion battery, taking into account the shortcomings of the previous prototype, and its operation did not meet the expectations of the authors. And she also pointed out her hopelessness.

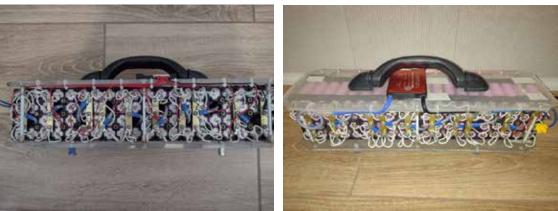
Battery № 1. The idea to build our own Liion battery came to us while browsing the range of electric bike kits. We were impressed by the price/capacity ratio and the significant amount of negative customer feedback. It was decided to manufacture its own Li-ion battery for 21 A*h with a nominal voltage of 36V, using Li-ion cells "18650". The purchase of elements with a declared capacity of 3.3 A*h was made on the AliExpress trading platform. The design of the battery included 10 serially connected assemblies of 7 cells each. Thus, the battery consisted of 70 Li-ion cells. To protect and "balance" the elements in discharge and charge modes, a 10S36V BMS board [2] was connected according to the diagram in (fig. 2). Balancing wires of the BMS board in (fig. 1) in red insulation.

Figure 1. The first 21 Ah, 36 V Li-ion battery with BMS board

Design features:

- "18650" cell holders in the form of honeycombs, which were purchased on AliExpress, were used;
- honeycomb holders were additionally equipped with bronze threaded bushings (glued with epoxy glue);

- branches from the elements are made with a flexible wire PV3 1*0.75 with the help of soldering to the element and pressing with a copper, tinned tip towards the assembly;
- each element could be disconnected from the assembly for the purpose of diagnosis and recharging, for which a

screw connection on the assemblies was used;

- the hams of the assemblies were made of strip bronze, had an open design for the possibility of voltage measurement and separate recharging of the assemblies;
- prompt replacement of defective or "sick" elements was not foreseen.

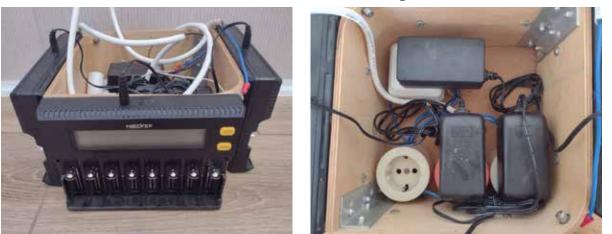
Three ZPs were mounted on a box-type plywood frame and received a rather compact charging station for 24 cells (Fig. 5) with the possibility of expansion to 32 cells. In the middle of the frame, 220 V sockets and power supply units of the ZP were placed.

Figure 5. Charging station based on "MIBOXER C8" for 24 elements

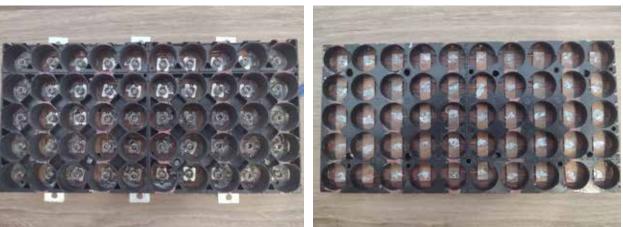
Let's go back to the battery. Design features (Fig. 6):

1. Already known honeycomb holders are used.

2. Copper strips and foiled fiberglass are used as assembly bars.

3. We used elastic elements purchased on AliExpress (steel springs on a steel holder), which were soldered to the conductive bronze layer of fiberglass.

4. The electric circuit of each element should be formed as a result of contact with the material

of the bars of the upper and lower bases of the cassette.

Figure 6. Upper and lower bases of the AB cassette

An excessive number of contact connections are used in the design of the current-carrying parts of the battery. Each element was in contact with the current-conducting parts of the bases, which included: steel springs, rolled in steel, nickel-plated holders, soldered to a bronze layer of foiled fiberglass; copper plates with tin solders, connected to each other with copper wires by the soldering method, etc.

The second mistake was the use of cell holders. The spread of the honeycomb cell caused a fairly tight insertion of the element. The holes in the honeycomb holders of the upper base were drilled to a larger size and conical shape for selfcentering of all elements and to achieve acceptable values of the compressive force of the bases (according to the criterion of their rigidity) and reliability of contact at the poles of the elements. However, it was not possible to achieve satisfactory results in improving the reliability of the electrical contact, especially in the lower base of the cassette. Too much variation in the values of transient resistances in the circuits of individual elements and, even, the complete "non-connection" of an element affected the participation of each element in feeding the load and led to the constant failure of the elements due to current overloads in the discharge cycle.
