### ASSESSMENT OF THE TECHNICAL CONDITION OF A ROAD BRIDGE

The road reinforced concrete bridge we inspected is located at kilometer 1333+14 on the M39 highway "Tashkent – Termez". The bridge is a three-span structure with a 3x16,5 m layout. The year of construction is unknown (Saatova N. Z., 2019).

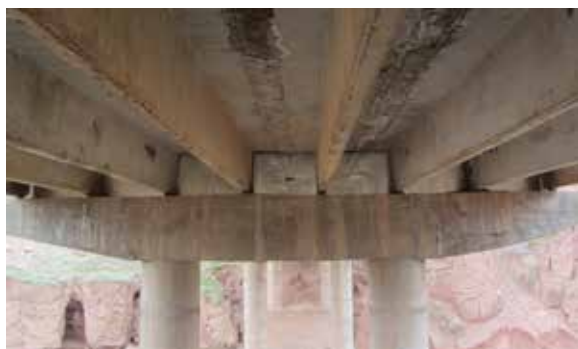
Due to prolonged use and the faulty condition of the waterproofing and expansion joints, water from the roadway has been constantly seeping onto the superstructure and supports. As a result, there are signs of leaching and corrosion on the surface of the beams and the concrete monolith between them (Photo 1);

**Photo 1.** *Traces of leaching and corrosion on the surface of the beams and the monolithic concrete between them*

**Prolonged Operation and Damage:** During the extended operation of the reinforced concrete road bridge on the 1333+14 km section, continuous wetting of the superstructures occurred due to the failure of the waterproofing layer. As a result, signs of leaching and concrete corrosion were found on the surface of the beams.

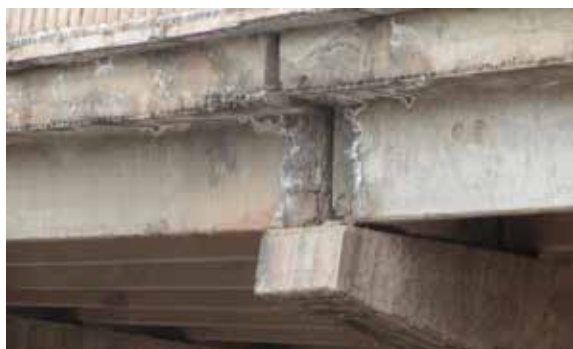
The ends of the outer beams in spans No. 1 and 2 are damaged due to concrete corrosion (Photo 2);

**Photo 2.** *Concrete corrosion at the ends of the outer beams*

**Failure of Expansion Joints:** Due to the failure of expansion joints over many years, surface water constantly affected the ends of the beams and supports. The ends of the outer beams in spans No. 1 and 2 have been destroyed due to concrete corrosion.

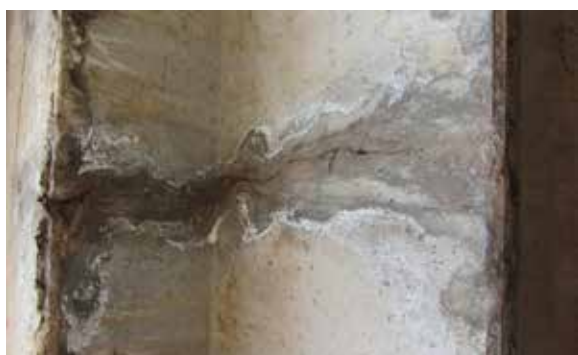
In the middle of the outer beam of span No. 1, a critical through-crack was identified, extending into the compressed concrete zone. The width of this crack reaches up to 5 mm (Photo 3). The bottom part of the beam is almost completely destroyed. Strengthening or replacement of this beam is required;

**Photo 3.** *Through-crack in the middle of the outer beam of the span, with a crack width of up to 5 mm*

**Beam Condition:** The outer beam of span No. 1, with unacceptable through-cracks in the middle of the span, requires either replacement or reinforcement.

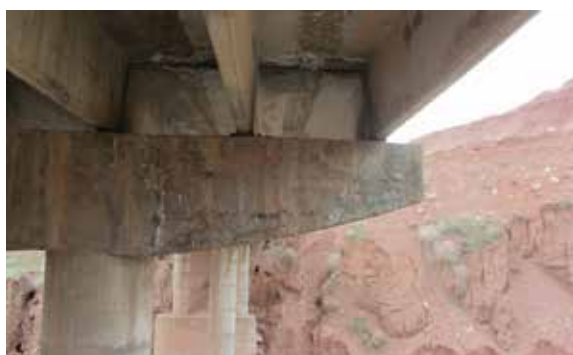
The concrete of the crossbeams is corroded, and the surfaces of the structures are covered with a network of cracks (Photo 4);

**Photo 4.** *Corrosion of the crossbeam concrete and a network of cracks on its surface*

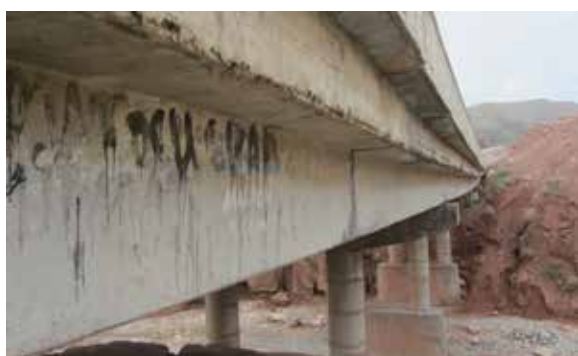
Based on the results of measuring the longitudinal profile of the bridge along the roadway, it appears that the river piers have settled by 30–40 cm due to scouring of the foundation (Photo 5).

**Photo 5.** *Scouring of the bridge foundation*

**Geodetic Survey Recommendations:** It is recommended to conduct detailed geodetic studies to determine the potential settlement of support No. 3.
